**CONSTRUCTION AND  
PERFORMANCE OF  
ULTRATHIN ASPHALT  
FRICTION COURSE**

**Prithvi S. Kandhal**  
**Associate Director**  
**National Center for Asphalt Technology**  
**Auburn University, Alabama**

**NCAT Report No. 97-5**

**September 1997**

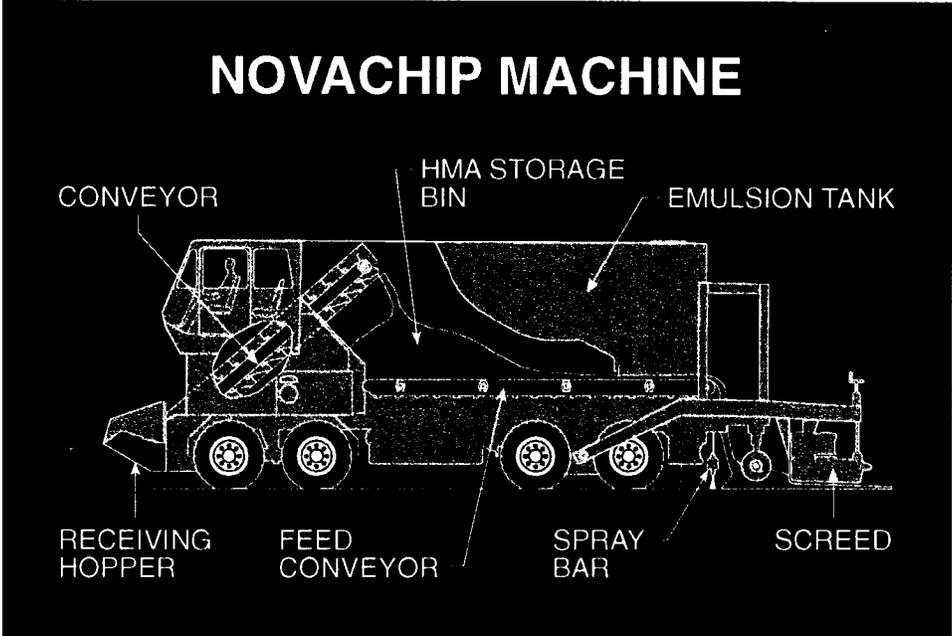
Figure 1. Schematic of Novachip Paving Machine

The paving machine (as shown in Figures 1 and 2) for Novachip placement consists basically of:

1. A receiving hopper to accept the gap-graded HMA from trucks.
2. Two auger conveyors that elevate the coated chips into an insulated storage bin.
3. An insulated emulsion storage tank.
4. Delivery conveyor which delivers the coated chips from the storage bin to the screed box.
5. An emulsion spray bar for tack coat application.
6. Distribution auger and a vibratory screed to place and level the coated chips.

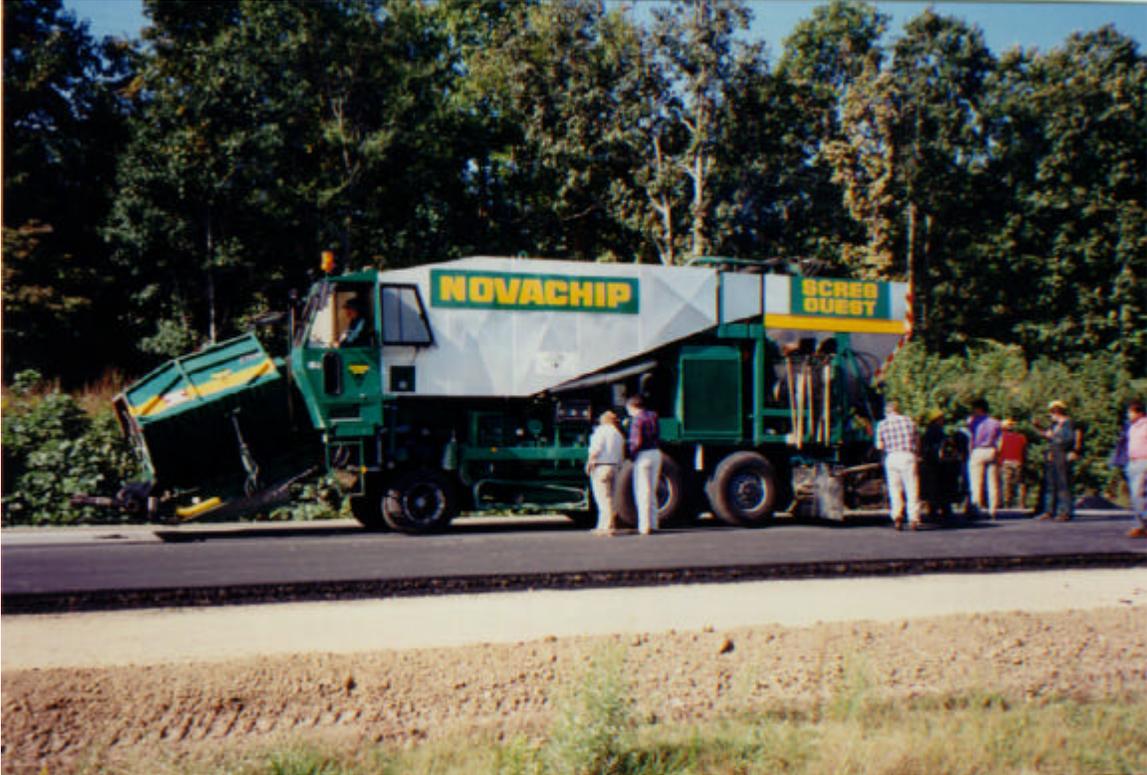
Figure 2. Novachip Paving Machine Used in Alabama

Novachip paving equipment (Figure 2) was imported from France. Primary operating personnel also came from France to demonstrate the equipment and place the test section. Figure 2 shows the receiving hopper at the left end of the machine, and tack coat spraying mechanism at the right end of the Novachip equipment.

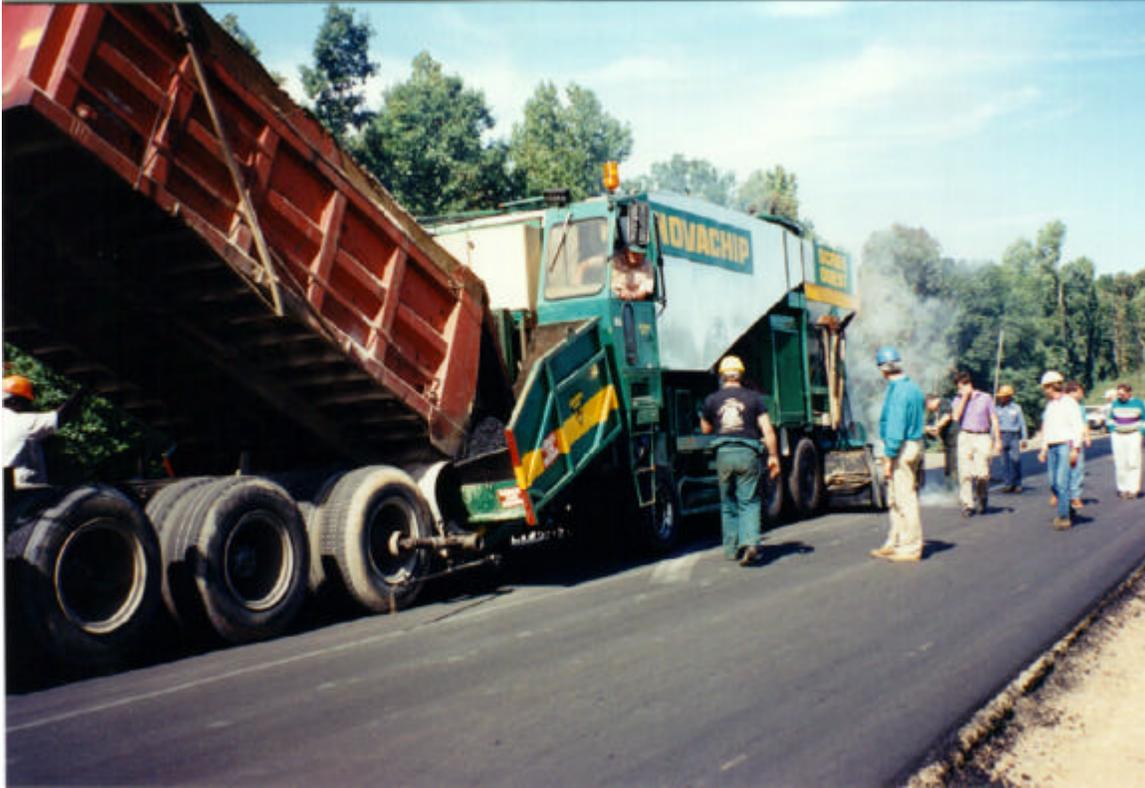
Figure 3. Truck Discharging Mix into Hopper

Novachip paving on this project was accomplished on October 1-2, 1992. The granite Novachip was placed on October 1 followed by the gravel Novachip on October 2. The ambient temperature ranged from 14 to 27°C (58 to 80°F). The machine traveled at a rate of 24-27 m (80-90 feet) per minute. Figure 3 shows a truck discharging mix into the hopper of Novachip machine. The Novachip surface after rolling appeared similar to an open-graded friction course (OGFC). Average rate of the Novachip mix used was  $30 \text{ kg/m}^2$  (55 lbs./sq. yd). The following observations were made during the construction.

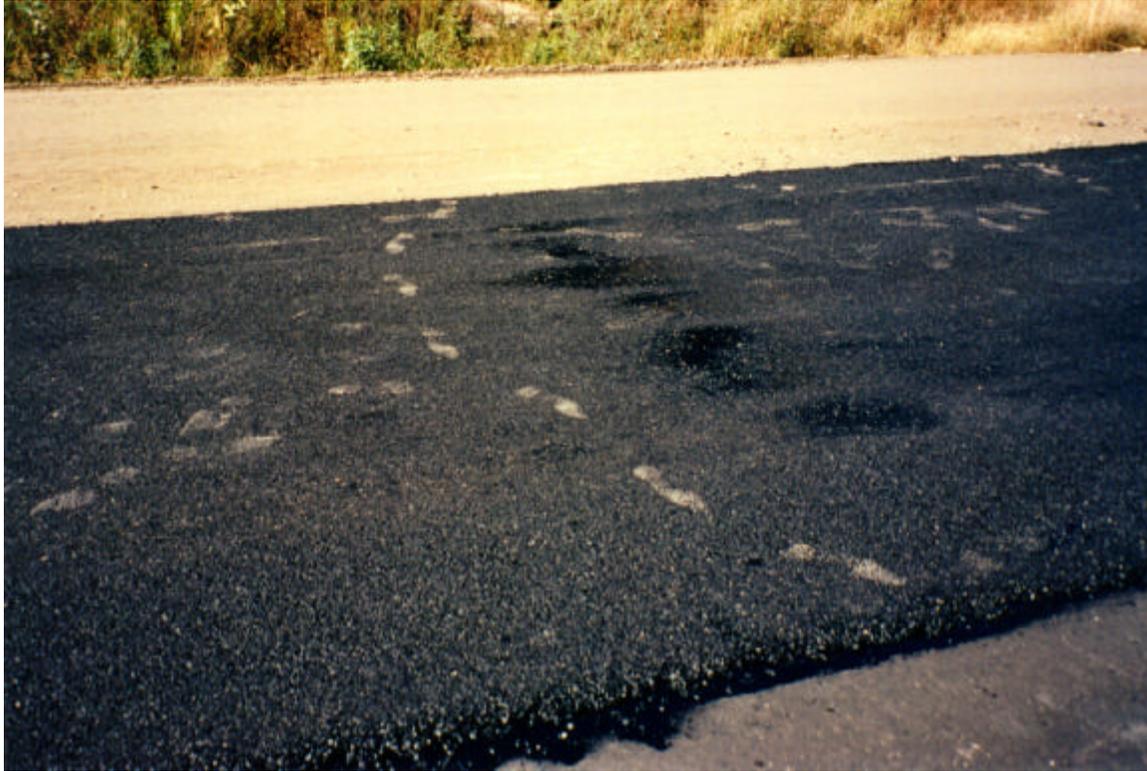
Figure 4. Tack Coat Puddles Where the Machine Stopped

1. The emulsion spray bar, pumping, and storage system created significant problems during the test section construction. The spray bar did not have positive closure at each spray nozzle. Whenever the emulsion distribution system was shut off, the material remaining in the spray bar drained (leaked) onto the pavement,

creating a large puddle of excess emulsion (Figure 4). In some locations where this situation occurred, excess emulsion was visible on the surface of the finished pavement. In addition, the system's emulsion storage tank did not have provisions for heating the emulsion. Therefore, maintaining the desired temperature of the tack coat was dependent on the Novachip paver's insulated tank's efficiency. These factors, in conjunction with the opening size of spray bar nozzles, and the equipment's speed of travel had an influence on the varying rates of tack coat application.

1. Spotty flushing of emulsion tack coat through the Novachip mix was caused from equipment related problems. The nozzles in the spray bar did not have a positive shut off and leaked when the machine stopped.
2. The amount of tack coat should be lower in a travel lane as compared to a passing lane to minimize flushing in the wheel tracks of the travel lane.
3. The surface texture of Novachip is very similar to that of a typical open-graded friction course.
4. No significant raveling was observed on these two projects after about 3-3/4 years, which indicates very good bond between Novachip and underlying surface.
5. Novachip surface had significantly higher pavement surface friction numbers

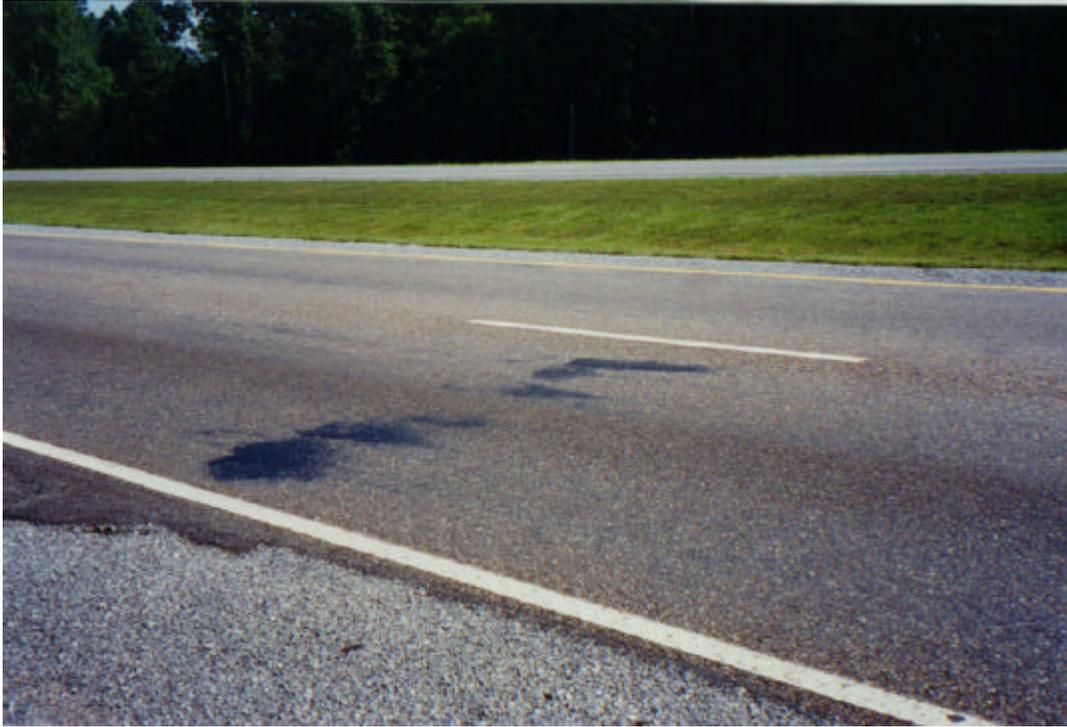
Figure 5. Tallapoosa Project - Flushing Due to Spray Bar Leakage

The 1996 average daily traffic (AADT) on this road is 13,044 with 10-1/2% trucks. No significant loss of Novachip or raveling has taken place in both granite and gravel test sections. This indicates very good adhesion between the Novachip and the underlying surface. As reported earlier, excessive emulsion tack coat puddles had resulted during construction from the leakage of spray bar wherever the machine stopped during paving. The excess emulsion was visible on the surface of the pavement within a year, and it was still evident after 3-3/4 years (Figure 5). This leakage problem was later rectified.

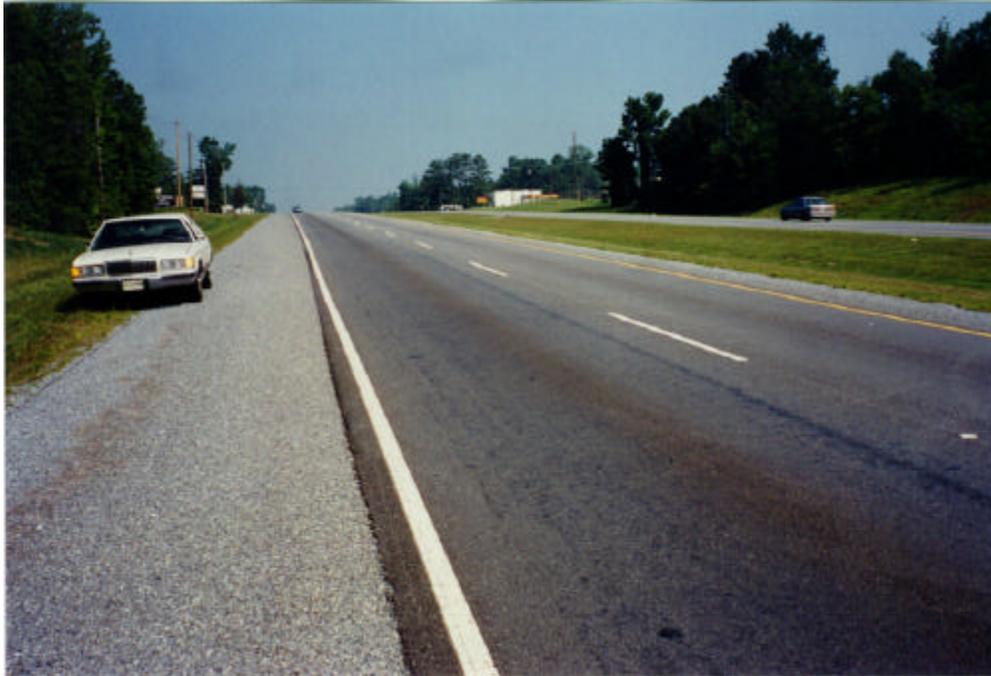
Figure 6. Tallapoosa Project - Granite Section Showing Moderate Flushing in Travel Lane (Left) and Slight Flushing in Passing Lane (Right)

The granite section which was placed first shows moderate flushing in the wheel tracks

of eastbound travel lane and slight flushing in the wheel tracks of the eastbound passing lane as shown in Figure 6. The gravel section which was placed on the following day shows slight flushing in the wheel tracks of the traffic lane and no flushing in the wheel tracks of the passing lane as shown in Figure 7. It is possible that the tack coat application rate was reduced and was just adequate for the gravel section. It appears that in future work the application rate should be maintained lower for the traffic lane compared to that for the passing lane. It was observed in both granite and gravel sections that worn aggregate was visible at the surface and was not covered by flushed asphalt binder. Therefore, frictional resistance of the flushed areas should not be adversely affected much.

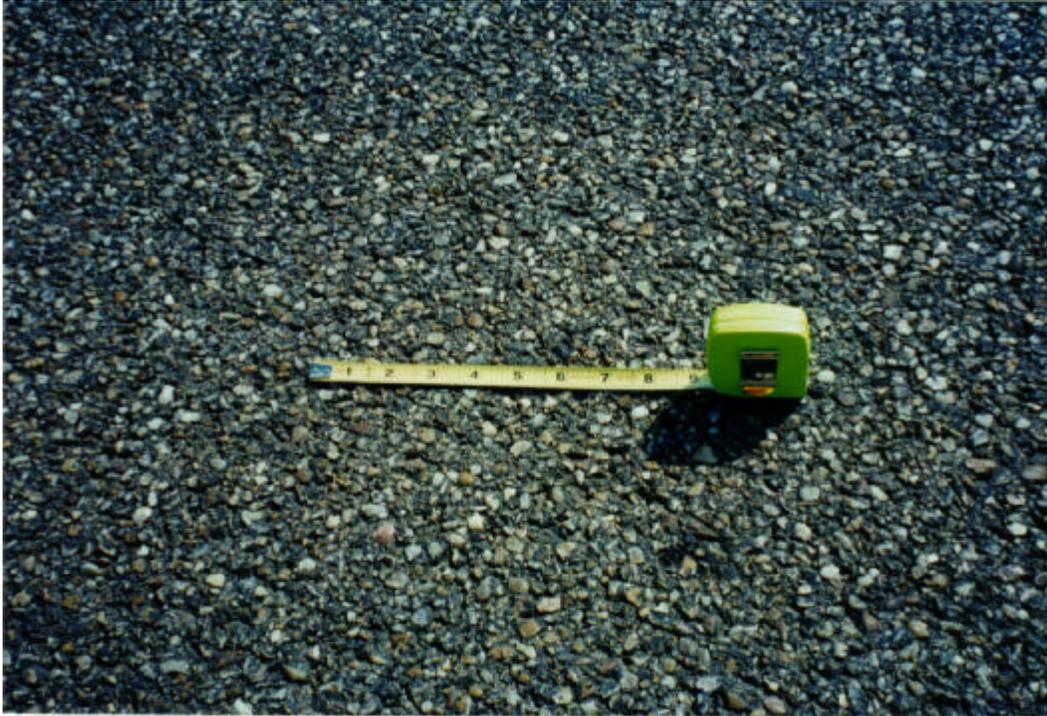
Figure 8. Tallapoosa Project - Closeup of Gravel Novachip Surface After 3-3/4 Years

Figure 8 shows a close-up of gravel Novachip surface which appears like the surface of a typical open-graded friction course (OGFC). Figure 9 shows a comparatively dense surface of the control section which used dense-graded wearing course mix (AL Designation 416) consisting of granite aggregate.

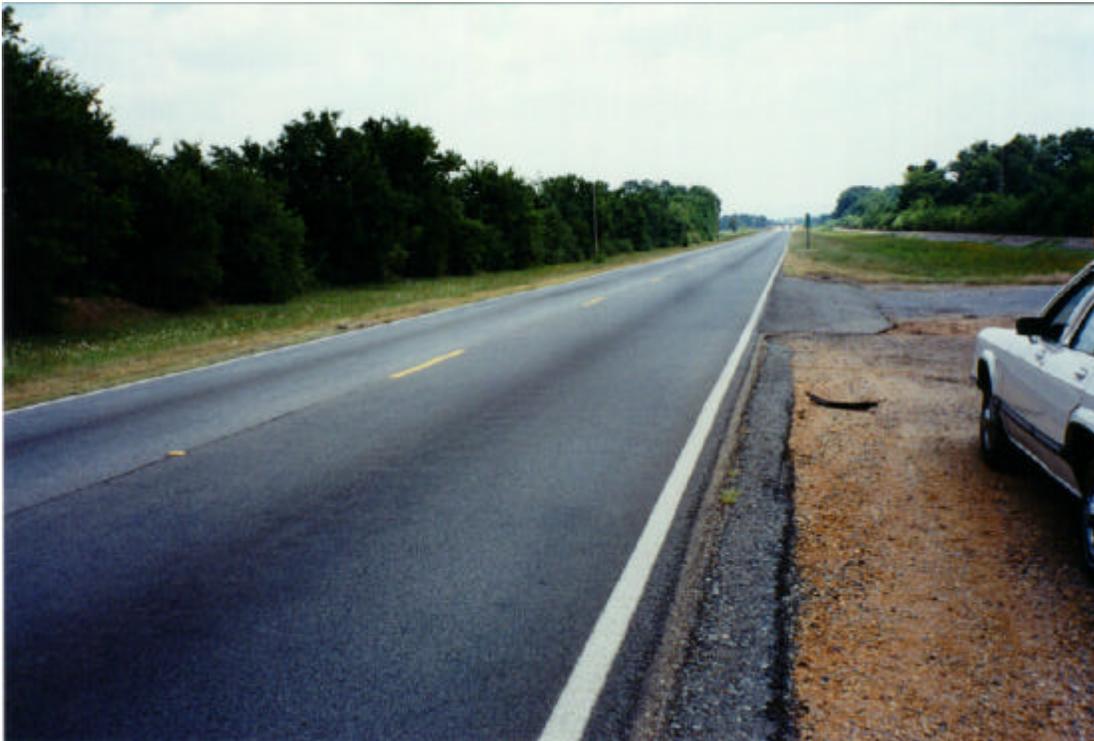
Figure 10. Talladega Project - General Uniform Appearance of Novachip Surface

coat bleed through the Novachip mix in wheel tracks and scattered areas at some places. This two-lane highway has a high crown and uneven surface. It appears that tack coat puddles in the wheel tracks and scattered depressions have caused the flushing problem. Obviously, Novachip cannot effectively remove large surface irregularities. It is also possible that the existing surface was non-uniform in surface texture and, therefore, absorbed the emulsion tack coat to different degrees. However, the Novachip surface is reasonably uniform and generally acceptable on this project (Figure 10). Even in scattered flushed areas, the worn granite aggregate is visible at the surface and, therefore, slight flushing should not adversely affect the surface friction. The surface appears much more uniform after 3-3/4 years' service compared to the surface just after construction.
